Naval Surface Warfare Center

NSWCCD-61-TR-2003/09

Technical Report

Spray Forming Iron Based Amorphous Metals

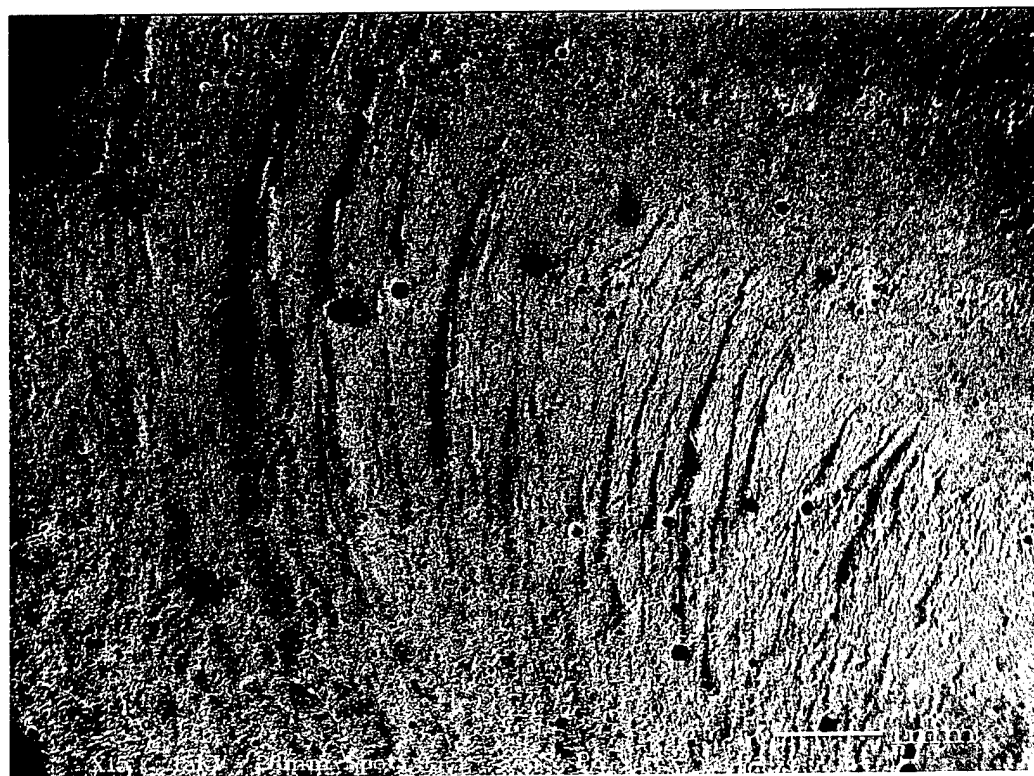
Figure 16. Scanning Electron Microscope, Secondary Electron Image of Fracture Surface on Piece of As-sprayed DAR35 From Run 537.
